Surface Morphology of Zinc after Irradiation by High Power Ion Beam

Abstract – Surface morphology of zinc irradiated by high power ion beam with average ion current density of 10–150 A/cm² and pulses number of 1–3 has been investigated. Optical microscopy and microinterferometer was used to analyse surface morphology irradiated sample. The morphology features on the irradiated zinc were craters and waviness. Clear wavy relief and surface cracks was observed for high power ion beam irradiated with small average ion current density. Results are discussed on basis of physical properties of the zinc and stress wave and the quasi-static thermal stresses induced by high power ion beam irradiation.

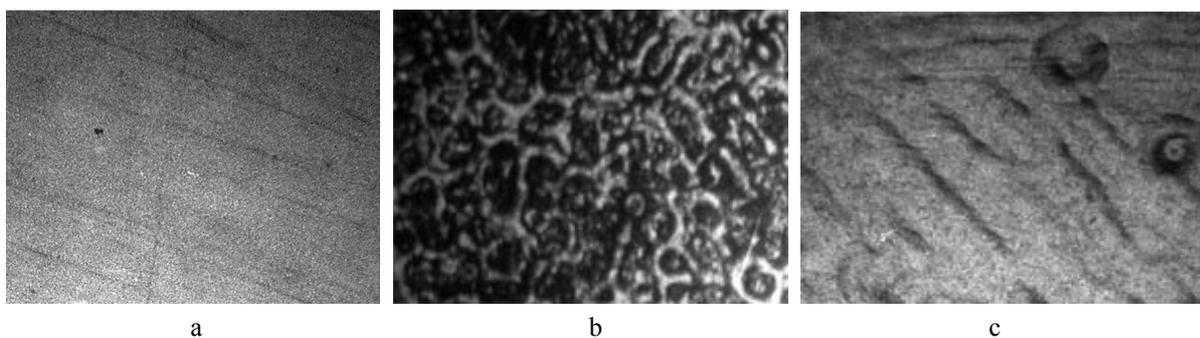
Figure 1 shows the surface morphology of the unirradiated sample zinc. As shown in Fig. 1 on the surface of sample the defects brought after polishing are present. Fig. 1,b–c shows the surface morphology of samples irradiated high power ion beam with different average ion current density. Fig. 1 indicates that the observed surface morphology depends on the average ion current density and the number of pulses. The surface morphology of irradiated samples was characterized by presence of the craters and waviness with different shapes and sizes. Single craters and clear wave relief was observed at irradiation high power ion beam with average ion current density of 10 A/cm². This wave relief is similar wave relief which was observed on Ni₃Al irradiated by high power ion beam [5]. The wave reliefs have various orientation at different grains of zinc.

Fig. 1. Surface morphology of: (a) the unirradiated samples and the irradiated by one pulse with average ion current density 150 (b), 10 (c) A/cm² ($\times 200$)

The wavelength of wave relief is practically the same as diameter of crater (see Fig. 1,c). Formation of the wave relief on the zinc surface for such small average ion current density can be explained by physical properties of zinc. Zinc have high velocity evaporation at liquid and solid state. Therefore, high pressure pulse appears at irradiation of zinc by a high power ion beam with small average ion current density. Such pulse may be the main factor responsible for the formation of wave relief [5]. Surface cracks at some grain zinc irradiated with average ion current density of 10 A/cm^2 was observed. This cracks appears after a solidification of the melted surface layer of the target.
